ERDC/CERL TR-03-5

Overcoating of Lead-Based Paint on Steel Structures

Cost and Performance Report

March 2003

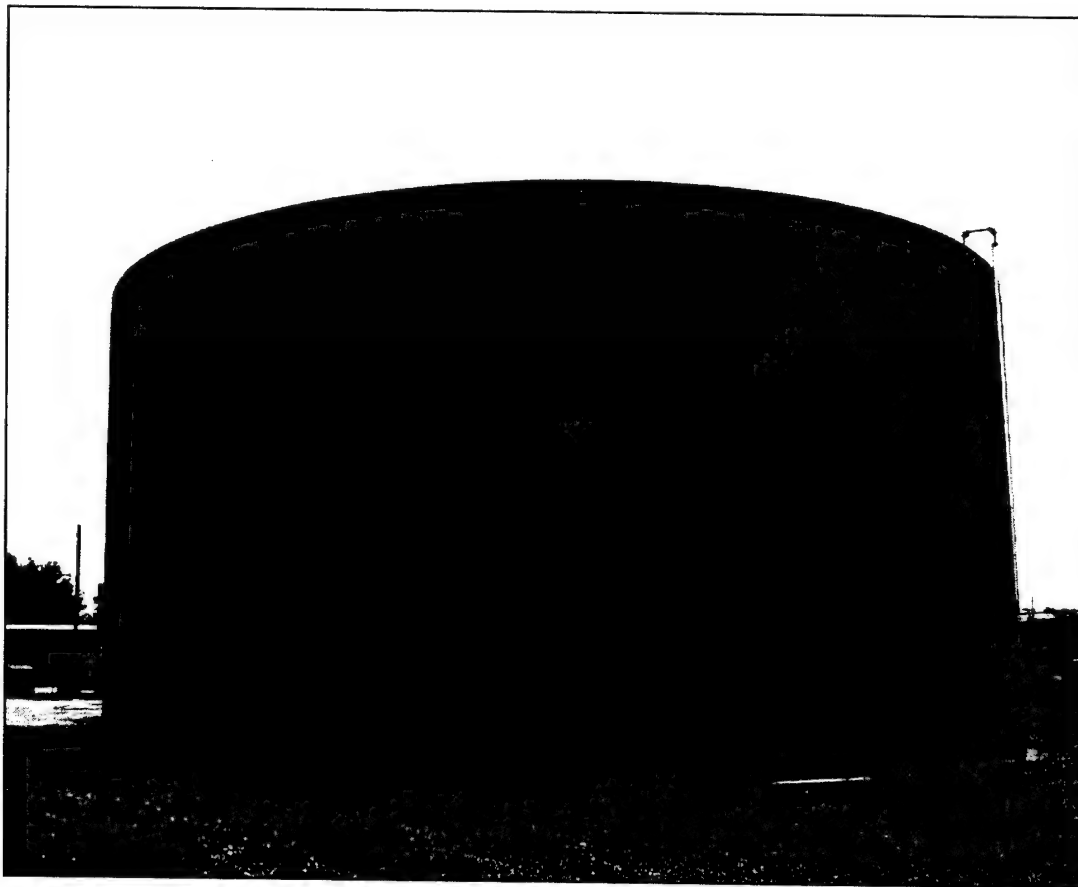
A visual inspection and physical tests were performed on the existing aged coating. Dry film thicknesses (DFTs) were measured at eight locations. The average thickness ranged from 2.0 to 4.1 mils. The overall average thickness is approximately 3.0 mils. Three adhesion measurements were taken, two with a south solar orientation and one with a north solar orientation. Crosscut adhesion values (ASTM D 3359 Method A) were 3A and 5A (south facing) and 3A (north facing), indicating slightly degraded intercoat adhesion.

Rusting ranged from 3 to 5 percent of the tank surface. Corrosion was primarily general spot corrosion with associated staining. The north side and lower portions of the tank were somewhat more degraded than the upper portions and south side. However, the rust distribution was fairly uniform overall.

Based on the generally low DFT and overall appearance, the tank has probably never been maintained or recoated.

Figure 1. Fort Campbell water tank prior to cleaning and overcoating.

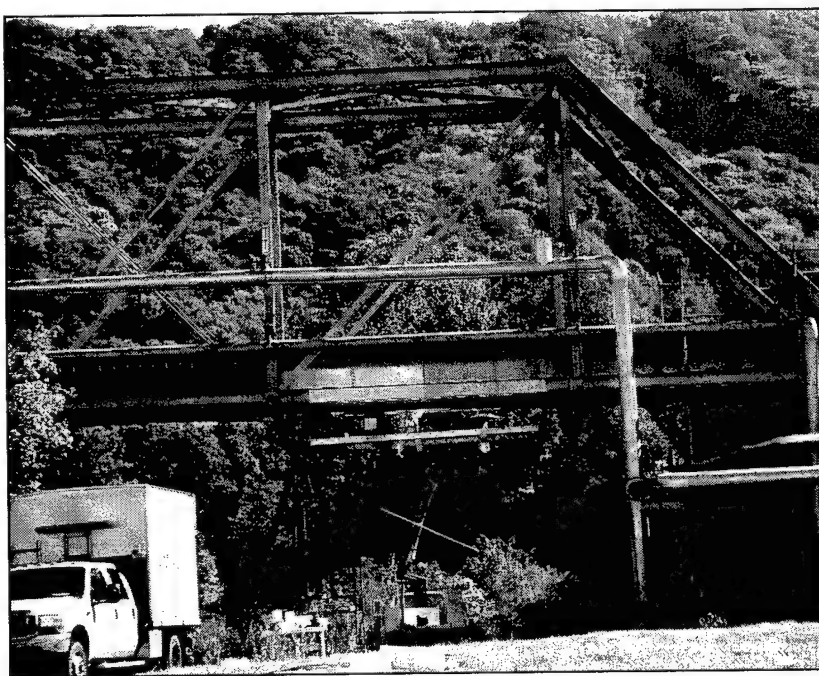
A visual inspection and physical tests were performed on the aged coating. The bridge appears to have been touched up and repainted on numerous occasions. It is doubtful that the bridge has been abrasive blasted and painted in at least the last 30 years and possibly not since it was erected at HAAP in 1943. The paint system is comprised of an orange primer and aluminum topcoat, which are probably TT-P-86, Type I, red lead in linseed oil and TT-P-38, aluminum phenolic finish coat. Most of the touchup painting was done with an aluminum finish coat. Paint film thicknesses are generally 8 to 15 mils on flat vertical surfaces and 20 to 25 mils on upward facing horizontal surfaces. The amount of visible rust is less than 1 percent of the total test area. Most of the rust was on the tops of flanges. Some rusted areas on the flanges were previously coated over and were lifting and curled. Adhesion tests were performed in accordance with ASTM D 3359 Method A X-cut tape test. Adhesion ranged from 4A to 5A. In some cases, a thin layer of aluminum pigment was lifted with the tape. This nonadherent material is the equivalent of chalk in a standard pigmented coating. A good deal of dirt had also accumulated on many of the bridge components.

Figure 2. Railroad bridge at HAAP, TN, with overcoated test areas.

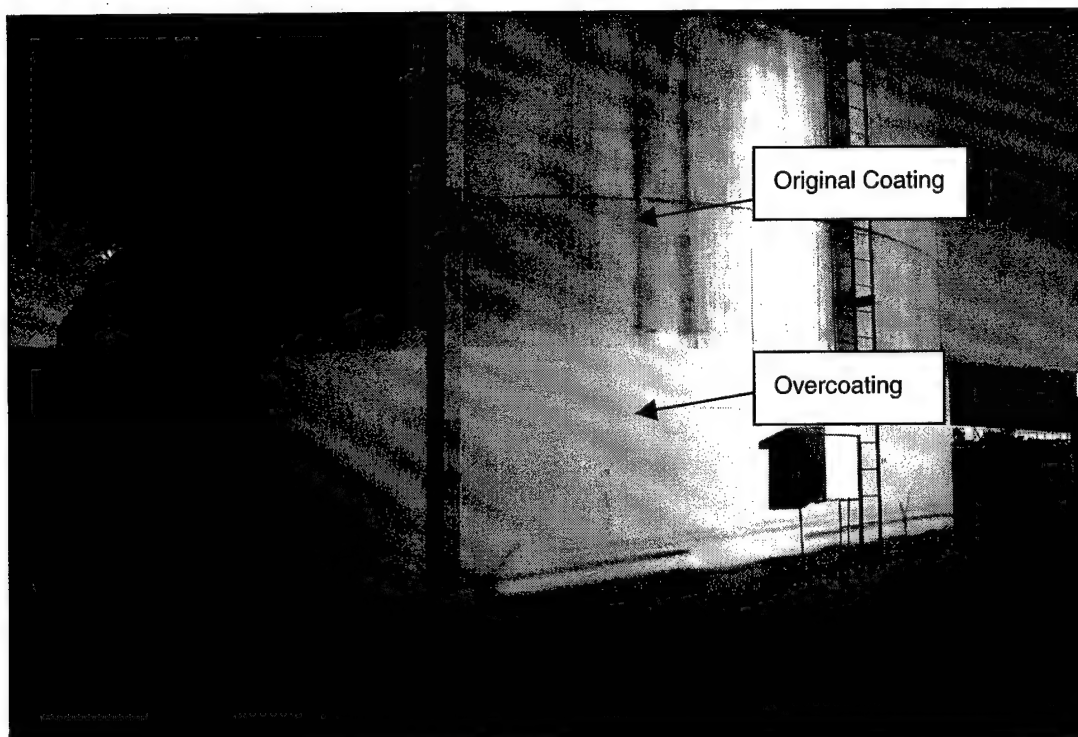
Figure 3. Deluge tank at Fort Campbell Army Airfield. (Original coating with lead-based paint primer visible at top is deteriorated and steel underneath is rusted. The tank was overcoated with test patches of moisture cure polyurethane in October 2000.)

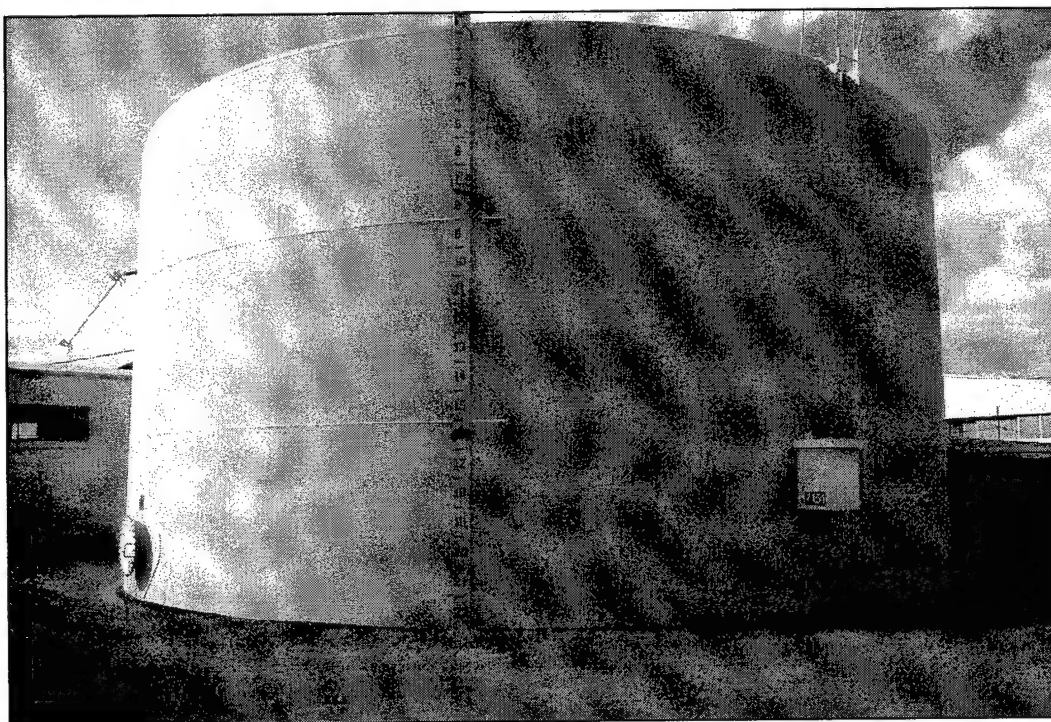
Figure 4. Deluge tank at Fort Campbell Army Airfield after overcoating completed in August 2001.

After evaluation of the two coating systems, the coating system composed of Sherwin-Williams Corothane I Mastic primer, Corothane I Ironox A intermediate, and Corothane I Ironox A topcoat was chosen for completion of the tank coating job, as shown in Figure 4. The projected life of the overcoat repair on this tank is 15 to 25 years. This projection is based on the pre-overcoat condition of the original paint system, the durability of the overcoat materials, and the severity of the exposure environment. It should also be noted that the water tank can probably be overcoated two more times provided its condition is not allowed to deteriorate past that which is suitable for overcoating.
